Coal Combustion Waste Impoundment

Round 5 - Dam Assessment Report

La Cygne Generating Station (Site 010)

Bottom Ash Settling, Upper and Lower AQC Ponds

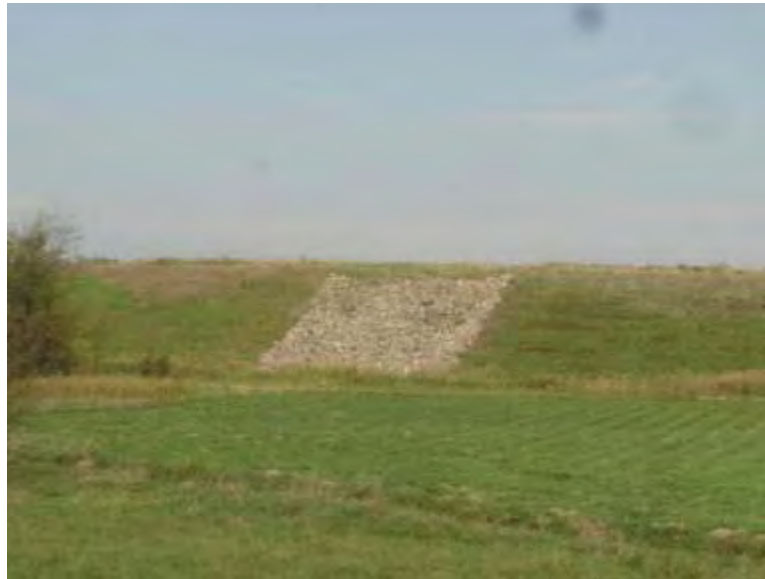
The Upper AQC Pond overflow structure is located at the center of southern embankment. The spillway consists of a 50-ft wide riprap lined channel over the embankment crest and the downstream slope. The opening for the spillway is shown to be 3 feet lower than the top of the embankment. The spillway design includes a 4-ft deep, 1-ft wide seepage cut off wall constructed at the inside crest of the embankment. The overflow drains directly into the La Cygne Generating Station cooling water lake. The structure appears to not have been used in recent history. Figure 5.3.1-1 shows the primary spillway structure for the Upper AQC Pond.

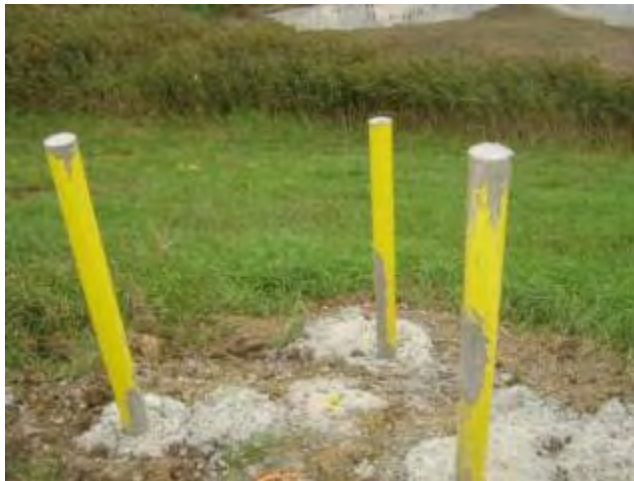
Figure 9.2-1

- eight settlement monuments along the dam crest (see Figure 9.2 -1)

Although the systems, instrumentation and equipment are installed, there was not a set of regular monitoring procedures in place.

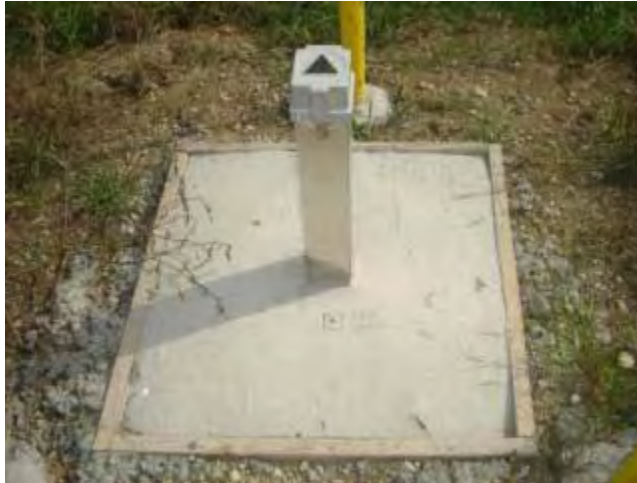
Figure 9.2-2

- Eleven Piezometers (see Figure 9.2-2).
